**Flood Control Project Maintenance  
Levee Inspections**

## Maintenance Issue Types Only, Levee Inspection Report By Mile - Spring 2019

### Reclamation District No. 0556 Upper Andrus

Waterway	Bank	Unit Miles	Inspection Start/End	Inspector
Unit No. 01 Georgiana Slough	Right	5.48	03/21/2019 03/21/2019	David Julian

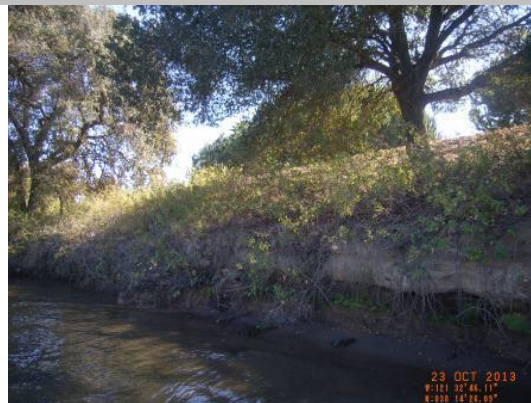
Photo 1 of 1 : SP\_2019\_RD0556\_19\_18\_20190311\_00006.jpg

LM Start	1.45	Rating **	M	Issue No.	18
LM End	1.59	Issue Type +	Ma	Location *	WS
Category	Supplemental			GPS Latitude/Longitude	
				Start	End
Item	2017 USACE Erosion Survey, DRAFT			38.240401 °	38.240772 °
				-121.544106 °	-121.546791 °
DWR ID	DWR_RD0556_02_f_2018_18				
Comment Code					
Inspector Comment					
2017 Site ID: SAC 24.8 L					
Status: Eroding					
2017 Field Notes: Significant lower bank erosion.					
Site History: 1997 - Slow erosion of the berm at the waterline; bench below water. 2005 - Brush boxes present. 2010 - Minor new erosion.					
2013 - There is little to no berm remaining at downstream end of this site. 2016 - New erosion on levee slope.

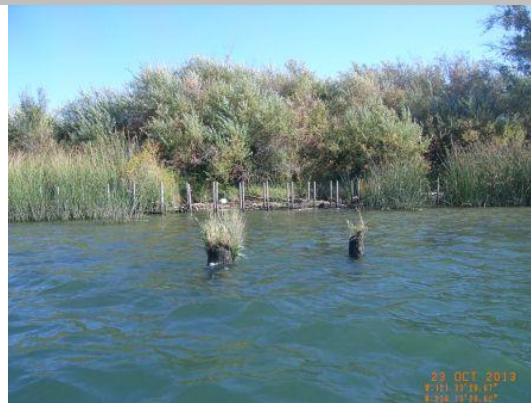
Photo 1 of 1 : SP\_2019\_RD0556\_19\_17\_20190311\_00005.jpg

LM Start	3.17	Rating **	M	Issue No.	17	
LM End	3.28	Issue Type +	Ma	Location *	WS	
Category	Supplemental			GPS Latitude/Longitude		
				Start	End	
Item	2017 USACE Erosion Survey, DRAFT			38.224850 °	38.223233 °	
				-121.555641 °	-121.555687 °	
DWR ID	DWR_RD0556_02_f_2018_17					
Comment Code						
Inspector Comment						
2017 Site ID: SAC 23.2 L Status: Eroding 2017 Field Notes: New erosion along lower bank. Site History: 2000 - Recently fallen cottonwood at the downstream end. 2005 - Empty brush boxes. 2011 - A few trees have fallen since last year. 2012 - Potential new tree popout since last year. 2013 - New erosion at downstream end of site and a recent tree pop-out observed. 2016 - New erosion at the toe.

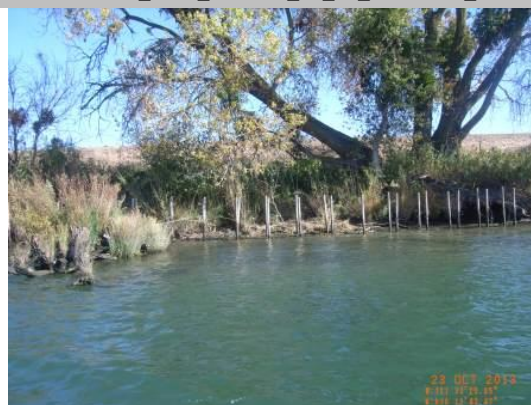
Photo 1 of 1 : SP\_2019\_RD0556\_19\_15\_20190311\_00003.jpg

LM Start	3.95	Rating **	M	Issue No.	15
LM End	4.12	Issue Type +	Ma	Location *	WS
Category	Supplemental			GPS Latitude/Longitude	
				Start	End
Item	2017 USACE Erosion Survey, DRAFT			38.213581 °	38.211112 °
				-121.557197 °	-121.557042 °
DWR ID	DWR_RD0556_02_f_2018_15				
Comment Code					
Inspector Comment					
2017 Site ID: SAC 22.5 L					
Status: Eroding					
2017 Field Notes: New lower bank erosion at the upstream end. Locals placed rock in some erosion pockets.					
Site History: 2002 - Spot rock along berm, but not in the erosion pockets. 2005 - Some new minor stone revetment at the upstream end. Brush boxes present. 2006 - Currently installing new brush in downstream brush boxes. 2007 - Rock in middle portion for about 150 ft. 2010 - Some attempt at repairs but still has pockets of erosion. 2012 - More erosion along the toe.
